CLUTCH LEVER

Material:- Low carbon Steel

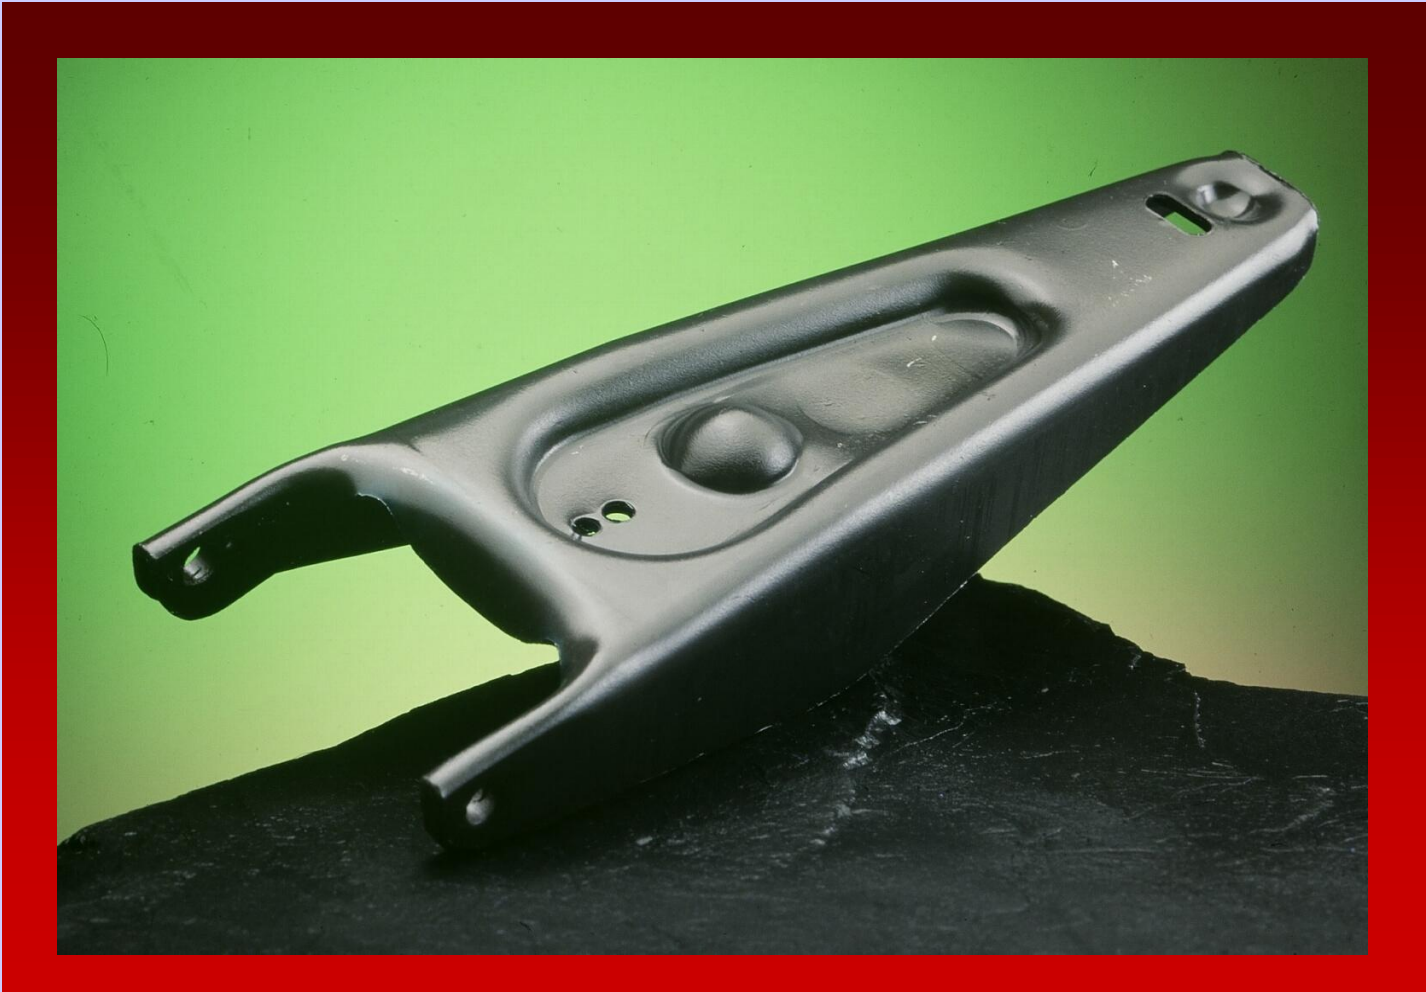
This is a Clutch Lever used on a 4 x 4 vehicle, the specified surface protection being a phosphate coating. Failure in service occurred due to wear in the pressed dome of the lever, this was caused by high pressure metal to metal contact with the clutch operating mechanism. The Nitrotec treatment gave increased strength together with the required wear resistance in the dome and eliminated the need for phosphate coating.
