SWIVEL HUB

SWIVEL HUB (cont)

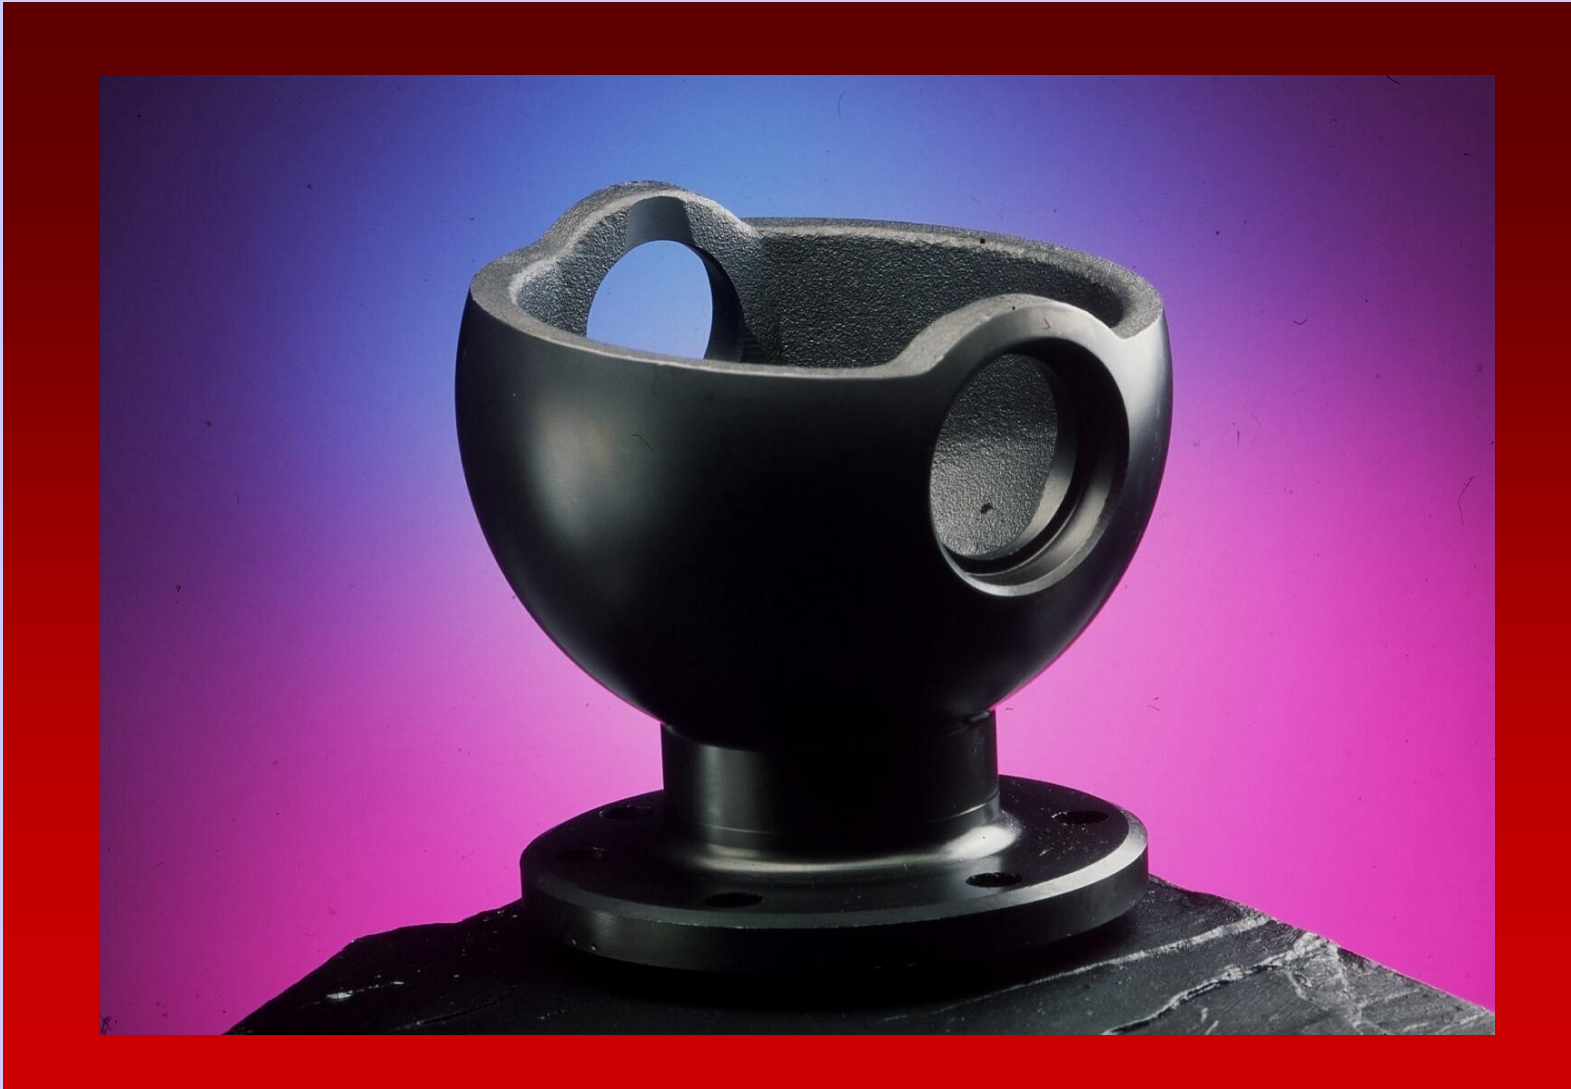
Many service complaints were being received about oil leaks around the seal which wiped over the bowl. The leaks were caused by the corrosion of the chrome plating, which was lifting up in flakes and cutting into the seal. The result being that the oil leak from the bowl depleting the oil reservoir inside the hub. One engineering solution experimented with was to fit the unit with a leather gaiter, packed with grease.

Unfortunately, corrosion occurred again giving rise to quality issues.

A Nitrotec treatment on the component with the correct surface finish produced greatly improved corrosion resistance, with an added bonus of improving fatigue strength to uplift available axle load.
