# *COVER PLATE*

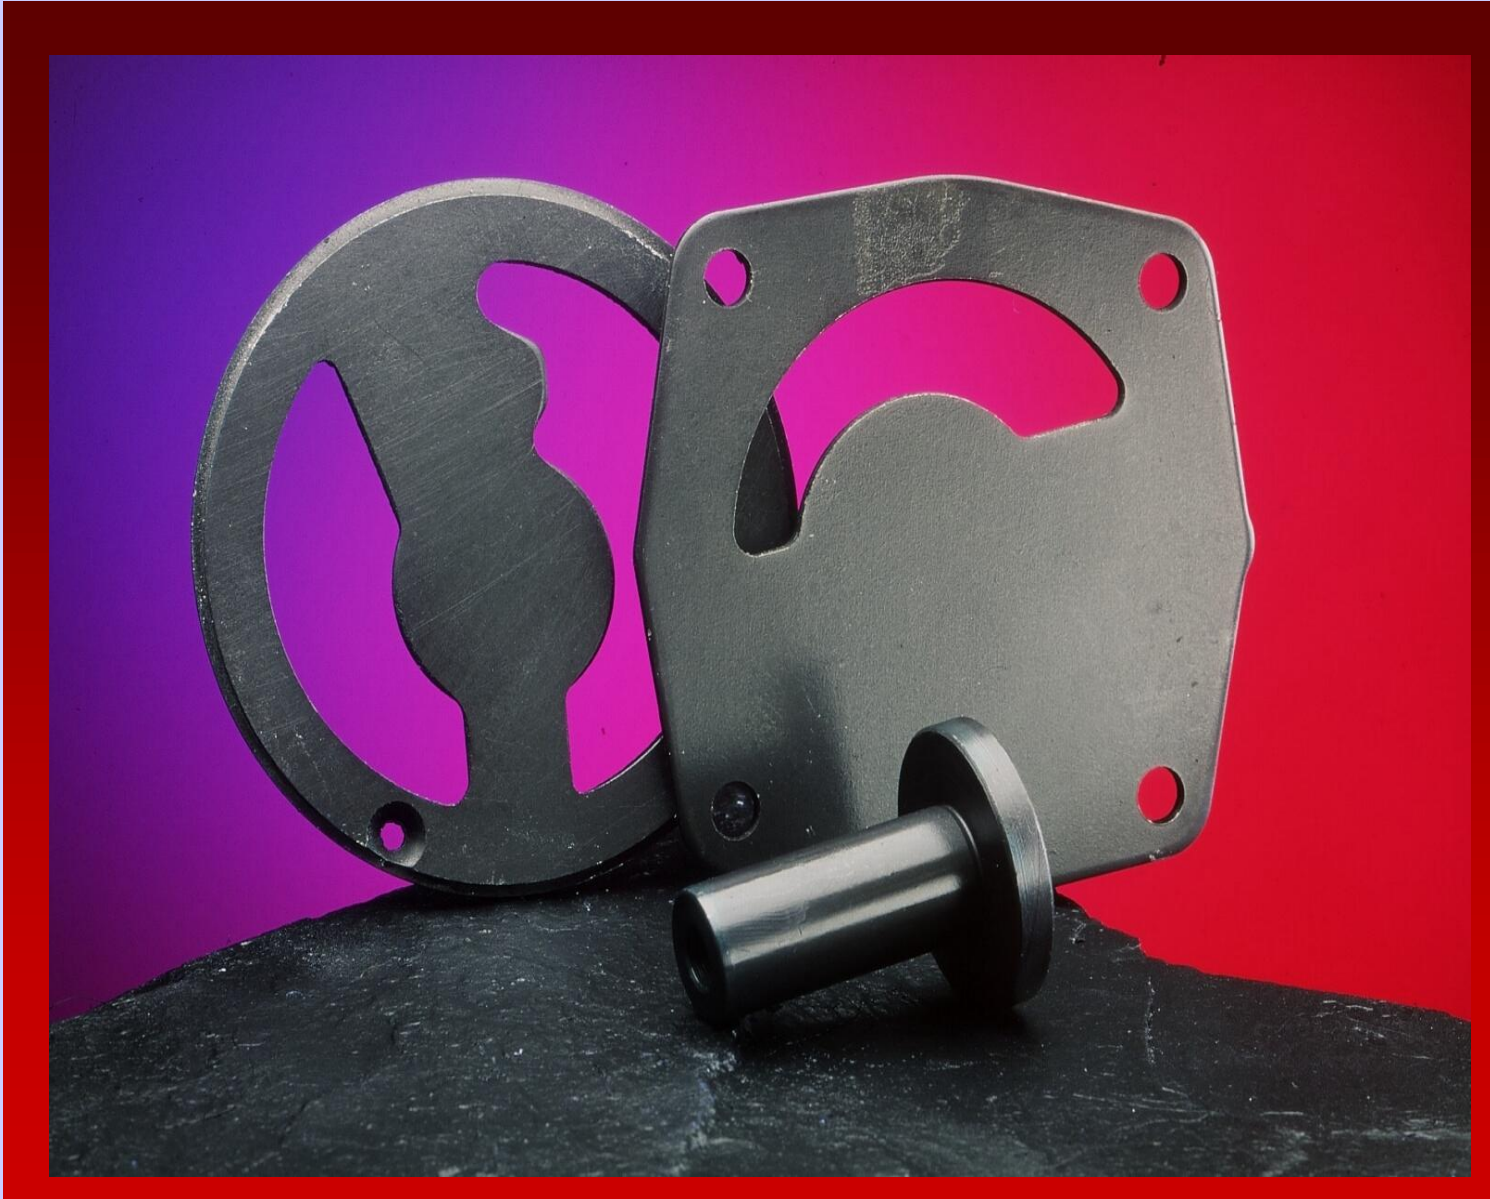
Material:- Hot rolled and pickled Low Carbon strip. Originally, this component was being treated by a competitive Salt bath treatment, unfortunately, this type of treatment left some form of contamination and at worst, a black deposit, which had to be removed by the customer using a post treatment cleaning cycle. Nitrotec was chosen because it was cost effective, giving a deeper, more consistent iron nitride layer with improved cleanliness removing the need for a post cleaning operation.
