FUEL BOWL BRACKET

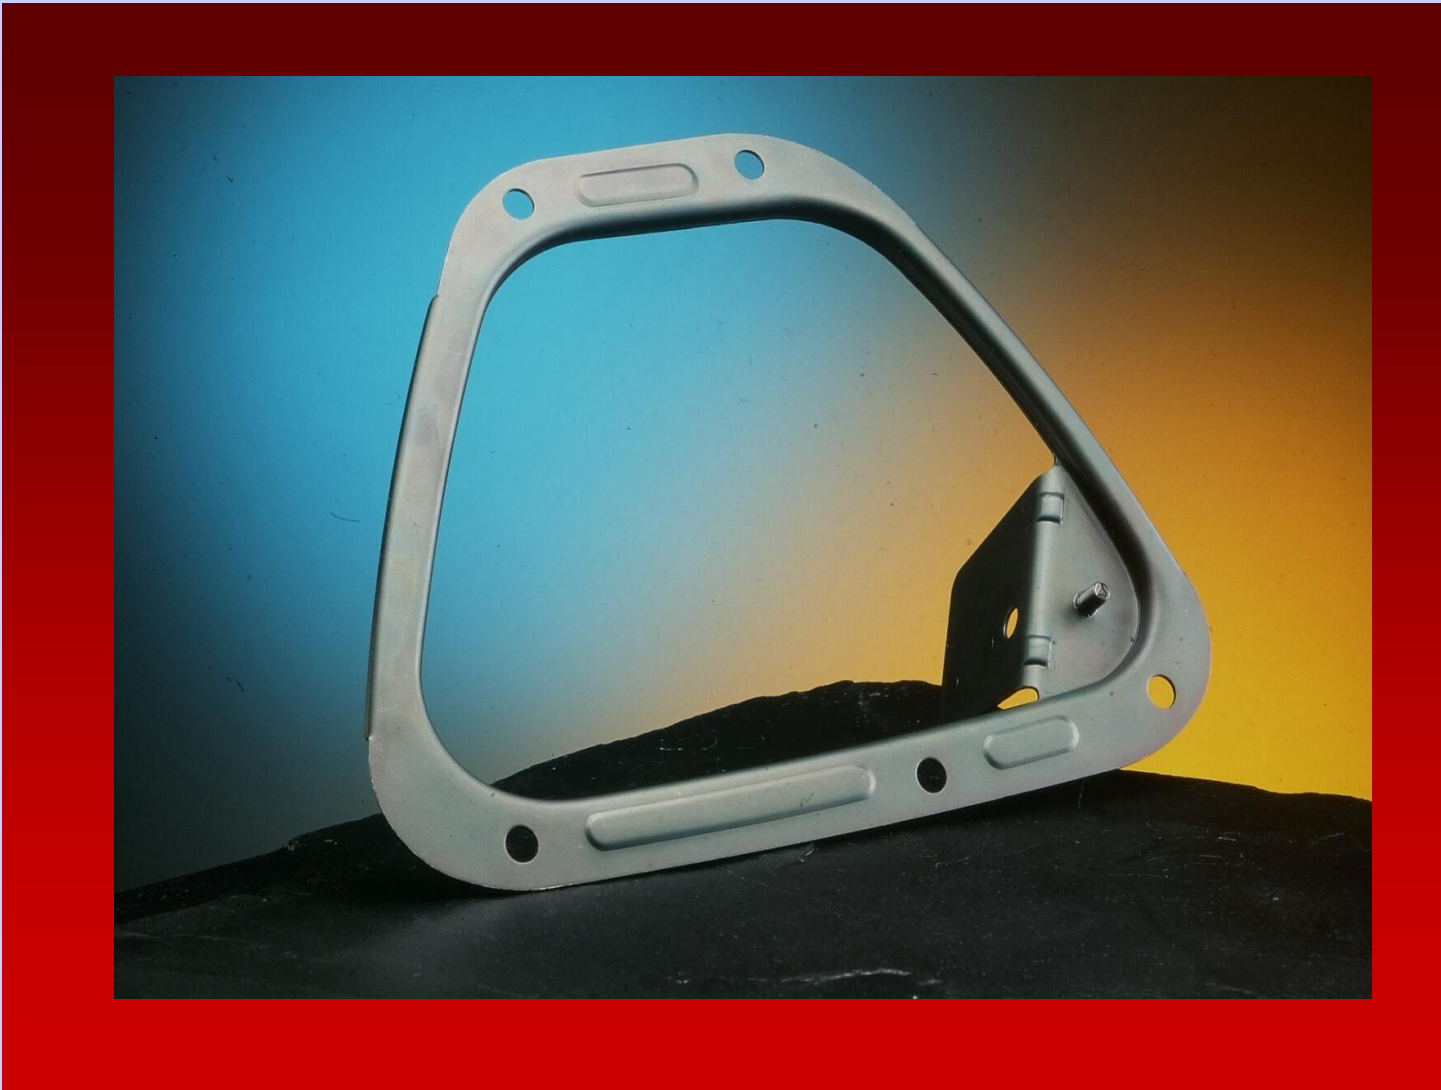
Material:- Low carbon steel.

This bracket was originally zinc electroplated followed by passivation, after which a rubber bowl shaped fixture was moulded into place. The bracket assembly was then fitted to an upmarket vehicle during which the bracket distorted creating difficulties for the assembly of this part. The application of a Nitrotec treatment followed by degreasing to enable moulding of the rubber bowl, thus, providing a total solution to the problem.
